TowerPinkster
Architecture · Engineering · Interiors

NOVEMBER 06, 2024

MUSKEGON COMMUNITY COLLEGE

CAMPUS PLAN REPORT

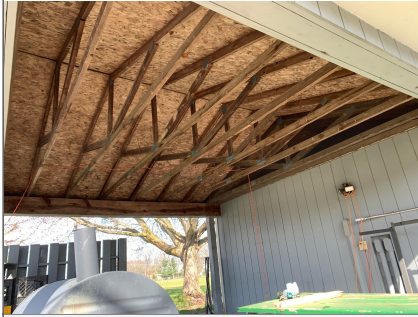
Covered back porch area, no ceiling (exposed roof trusses open to attic)

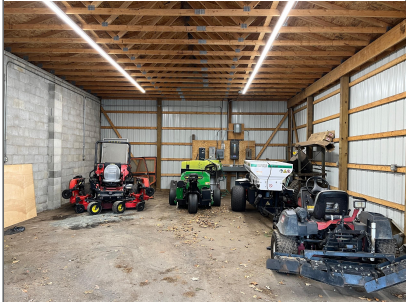
Typical Pole Barn Construction w/ CMU Rear Wall

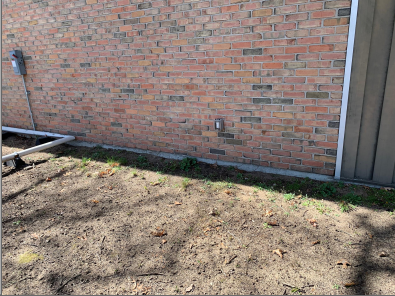
Brick veneer does not have weeps or vents required for drainage

Provide linear foot cost to add flashing & weeps in brick or stone veneer where there are no weep or flashing pres

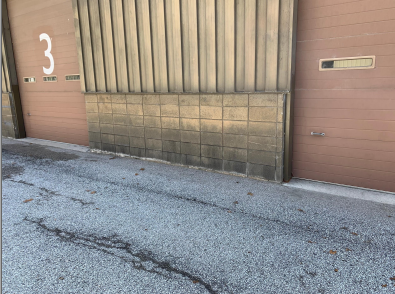
Stained CMU wainscot (no gutters water running down face)

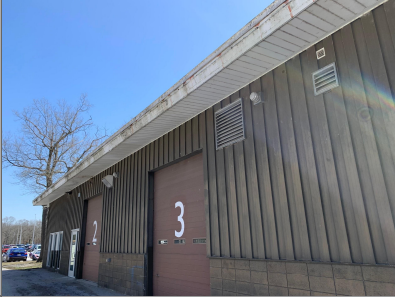
Stained fascia & soffit from lack of gutters

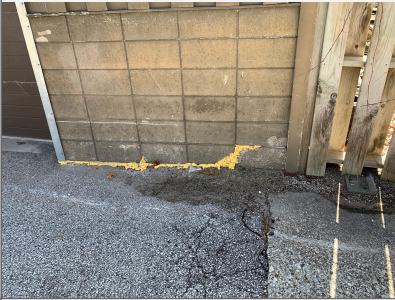
Spray foam leaking out of CMU

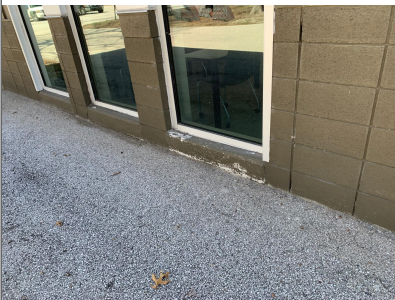
Solid concrete sills under windows (no weeps or flashing)
