2010 FACILITIES MASTER PLAN

Muskegon Community College

Muskegon, Michigan

August, 2010

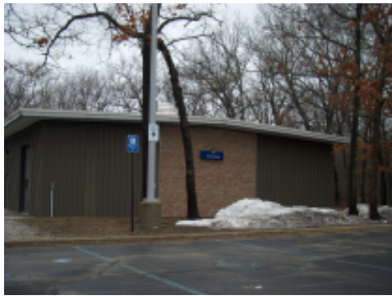
is unusable for instruction because it is not barrier-free. Storage is limited, and there is no means of securing individual rooms when they are not in use. The building lacks effective use of natural light, exhibit space for student work, and multi-media technology in each studio.

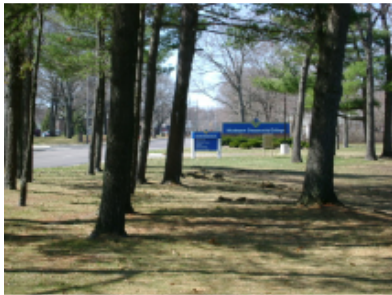
The original 111-acre campus (not including the University Park Golf Course) is bounded on the west by Harvey Street and US 31; on the north by Stebbins Road; on the east by Quarterline Road; and on the south by Marquette Avenue. Recently, the 6+ acres of land occupied by the Intermediate School District Career Tech Center was deeded to the ISD and is no longer owned by MCC. Also, there are several houses on the south side of Stebbins Road that are not owned by MCC. There is no direct access from US 31 to the College at Marquette Avenue or Harvey Street.

The campus site is comprised of wooded uplands cut east to west by a ravine, where Four Mile Creek flows. The northern and western portions of the campus are wooded with tall trees creating a deep woods environment. The southern and central portion of the site is mainly open land with scattered trees, lawns, sports fields and paved surfaces. A dense stand of trees on the southeast corner of the site adds to a sense of enclosure and screening from the roads surrounding it.

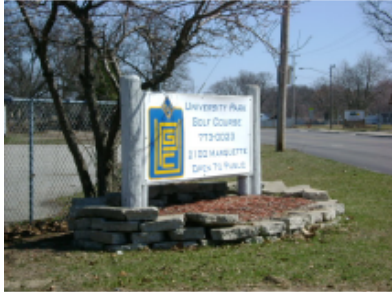
The nine-hole **University Park Golf Course** is located east of Quarterline Road (at 2100 Marquette) and includes a clubhouse building and a maintenance building. The course is bisected east/west by Four Mile Creek, and the land is gently rolling and is covered with scattered trees.

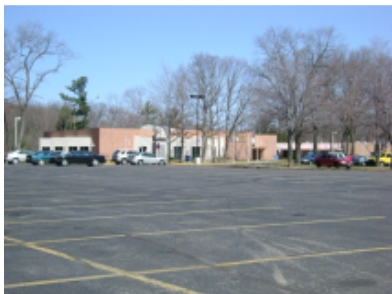
These entrances serve two large primary parking lots. The primary south lot is located south of the main academic building and may be entered from Marquette Avenue or from Quarterline Road. The primary north lot is located north of the Stevenson Center, and is entered from Quarterline Road. Additional parking lots are located south and west of the Bartels-Rode Gymnasium, near the Marquette Avenue entrance.

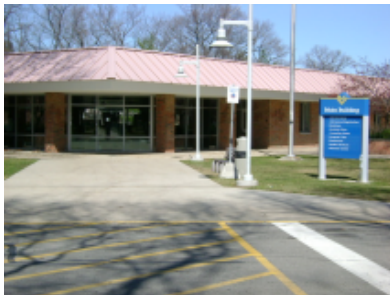
From the north parking lot, pedestrian movement is simple and safe. Walks pass through landscaped areas and offer seating opportunities and access to quiet areas.

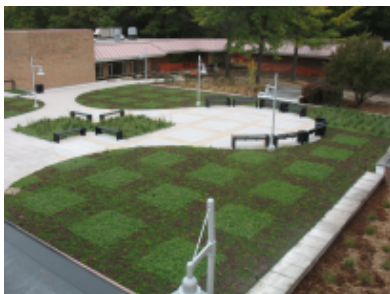
Pedestrian access to the central courtyard (streamside) is limited. An accessible, Outdoor Learning Center has been installed above the administration offices, and this area provides seating and opportunities for gathering for groups in a quiet setting.

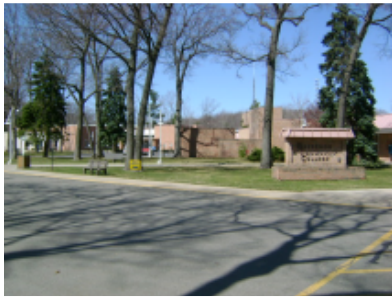
The Main Academic Building opened in 1967 and is the centerpiece of the MCC campus. As the primary location for most academic and administrative services on campus, it occupies three floors and features an outdoor courtyard in the center of the building, with Four Mile Creek flowing under the building and through the courtyard.

The Main Academic Building totaled a composite score between the “satisfactory” and “borderline” categories of the assessment instrument. While the building is generally in satisfactory condition, and has been maintained well, there are several reasons for the lower composite score.

Structurally, the building scored lower due to the poor condition of the existing roof. The College is currently engaged in a program that will result in the replacement of the roof of the entire Academic Building and Frauenthal Fine Arts Center, so the recommendation for a new roof is not included in this master plan.

The building envelope scored low because of the poor insulative quality of the existing roof, walls and glass areas, in addition to the condition of the existing exterior doors and frames. Many of these elements are original or in excess of twenty years old.

Interior finishes scored in the “satisfactory” range overall, but in significant locations of the Main Academic Building, finishes and casework are original and need upgrading, particularly within teaching spaces and office spaces. The Carr-Fles Planetarium requires total replacement of all equipment, fixtures, and finishes to achieve relevance into the future.

4. The domestic hot water recirculation system throughout the building should be renovated to provide on-demand hot water where needed.
5. MCC should renovate the planetarium, including replacement of all existing technical equipment with state-of-the-art digital systems, as well as replacement of all seating and enhancement of patron amenities.

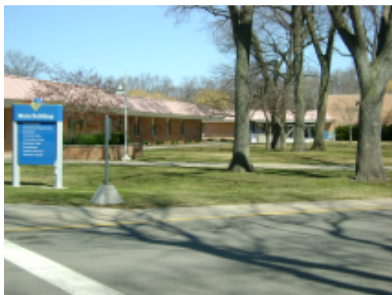
As in virtually all MCC facilities, this building is a steel-frame structure, with brick exterior. It has a standing-seam metal mansard roof element that unites every component of the first floor of the building. Interior corridors feature brick walls, and at corridor corners, large expanses of single-pane glass provide a visual connection to the outdoors, often to the creek flowing under the building. This element of an interior courtyard visible from many places on campus is common to several community colleges in Michigan designed by Alden B. Dow, who had a special affinity for the integration of architecture and nature.

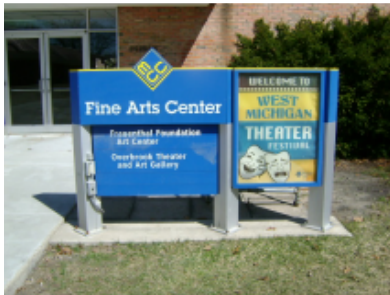
The Frauenthal Foundation Fine Arts Center opened in 1967 and includes the 344-seat Overbrook Theater and adjacent art gallery, where works by students, faculty and guest artists are exhibited. The center also includes a rehearsal room for band, orchestra, and chorus, practice rooms, a dance studio, and a piano lab.

From a site perspective, the Frauenthal site is satisfactory in its existing condition, though it lacks parking for theater staff and delivery vehicles. The sculpture court adjacent to the entrance appears neglected and little used.

The structural condition is “borderline”, due primarily to the condition of the existing roof, which is scheduled for replacement.

Interior finishes received a “satisfactory” assessment, though improvements should be made to doors, hardware, casework, and general finish condition, including the refurbishment of auditorium seating and auditorium space finishes.

1. Renovate the existing Frauenthal Theater, including refurbished seating, finishes, lighting, electrical service, mechanical systems, technology connectivity, and systems related to theater production, rigging, acoustical control, and sound booth equipment.
2. Expand the “back of house” spaces of the Frauenthal Theater, including expanded scene shop, costume storage, dressing rooms, and prop storage.
3. Renovate the music instruction area, including new finishes and lighting in rehearsal spaces, and enhanced instruction in the piano lab.

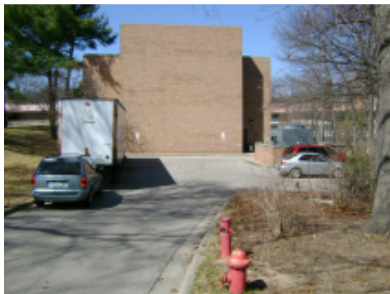
The building exterior is “borderline”, with a need for more prominent signage, an enhanced entrance, and overall curb appeal. Similarly, the facility is “borderline” in terms of accessibility.

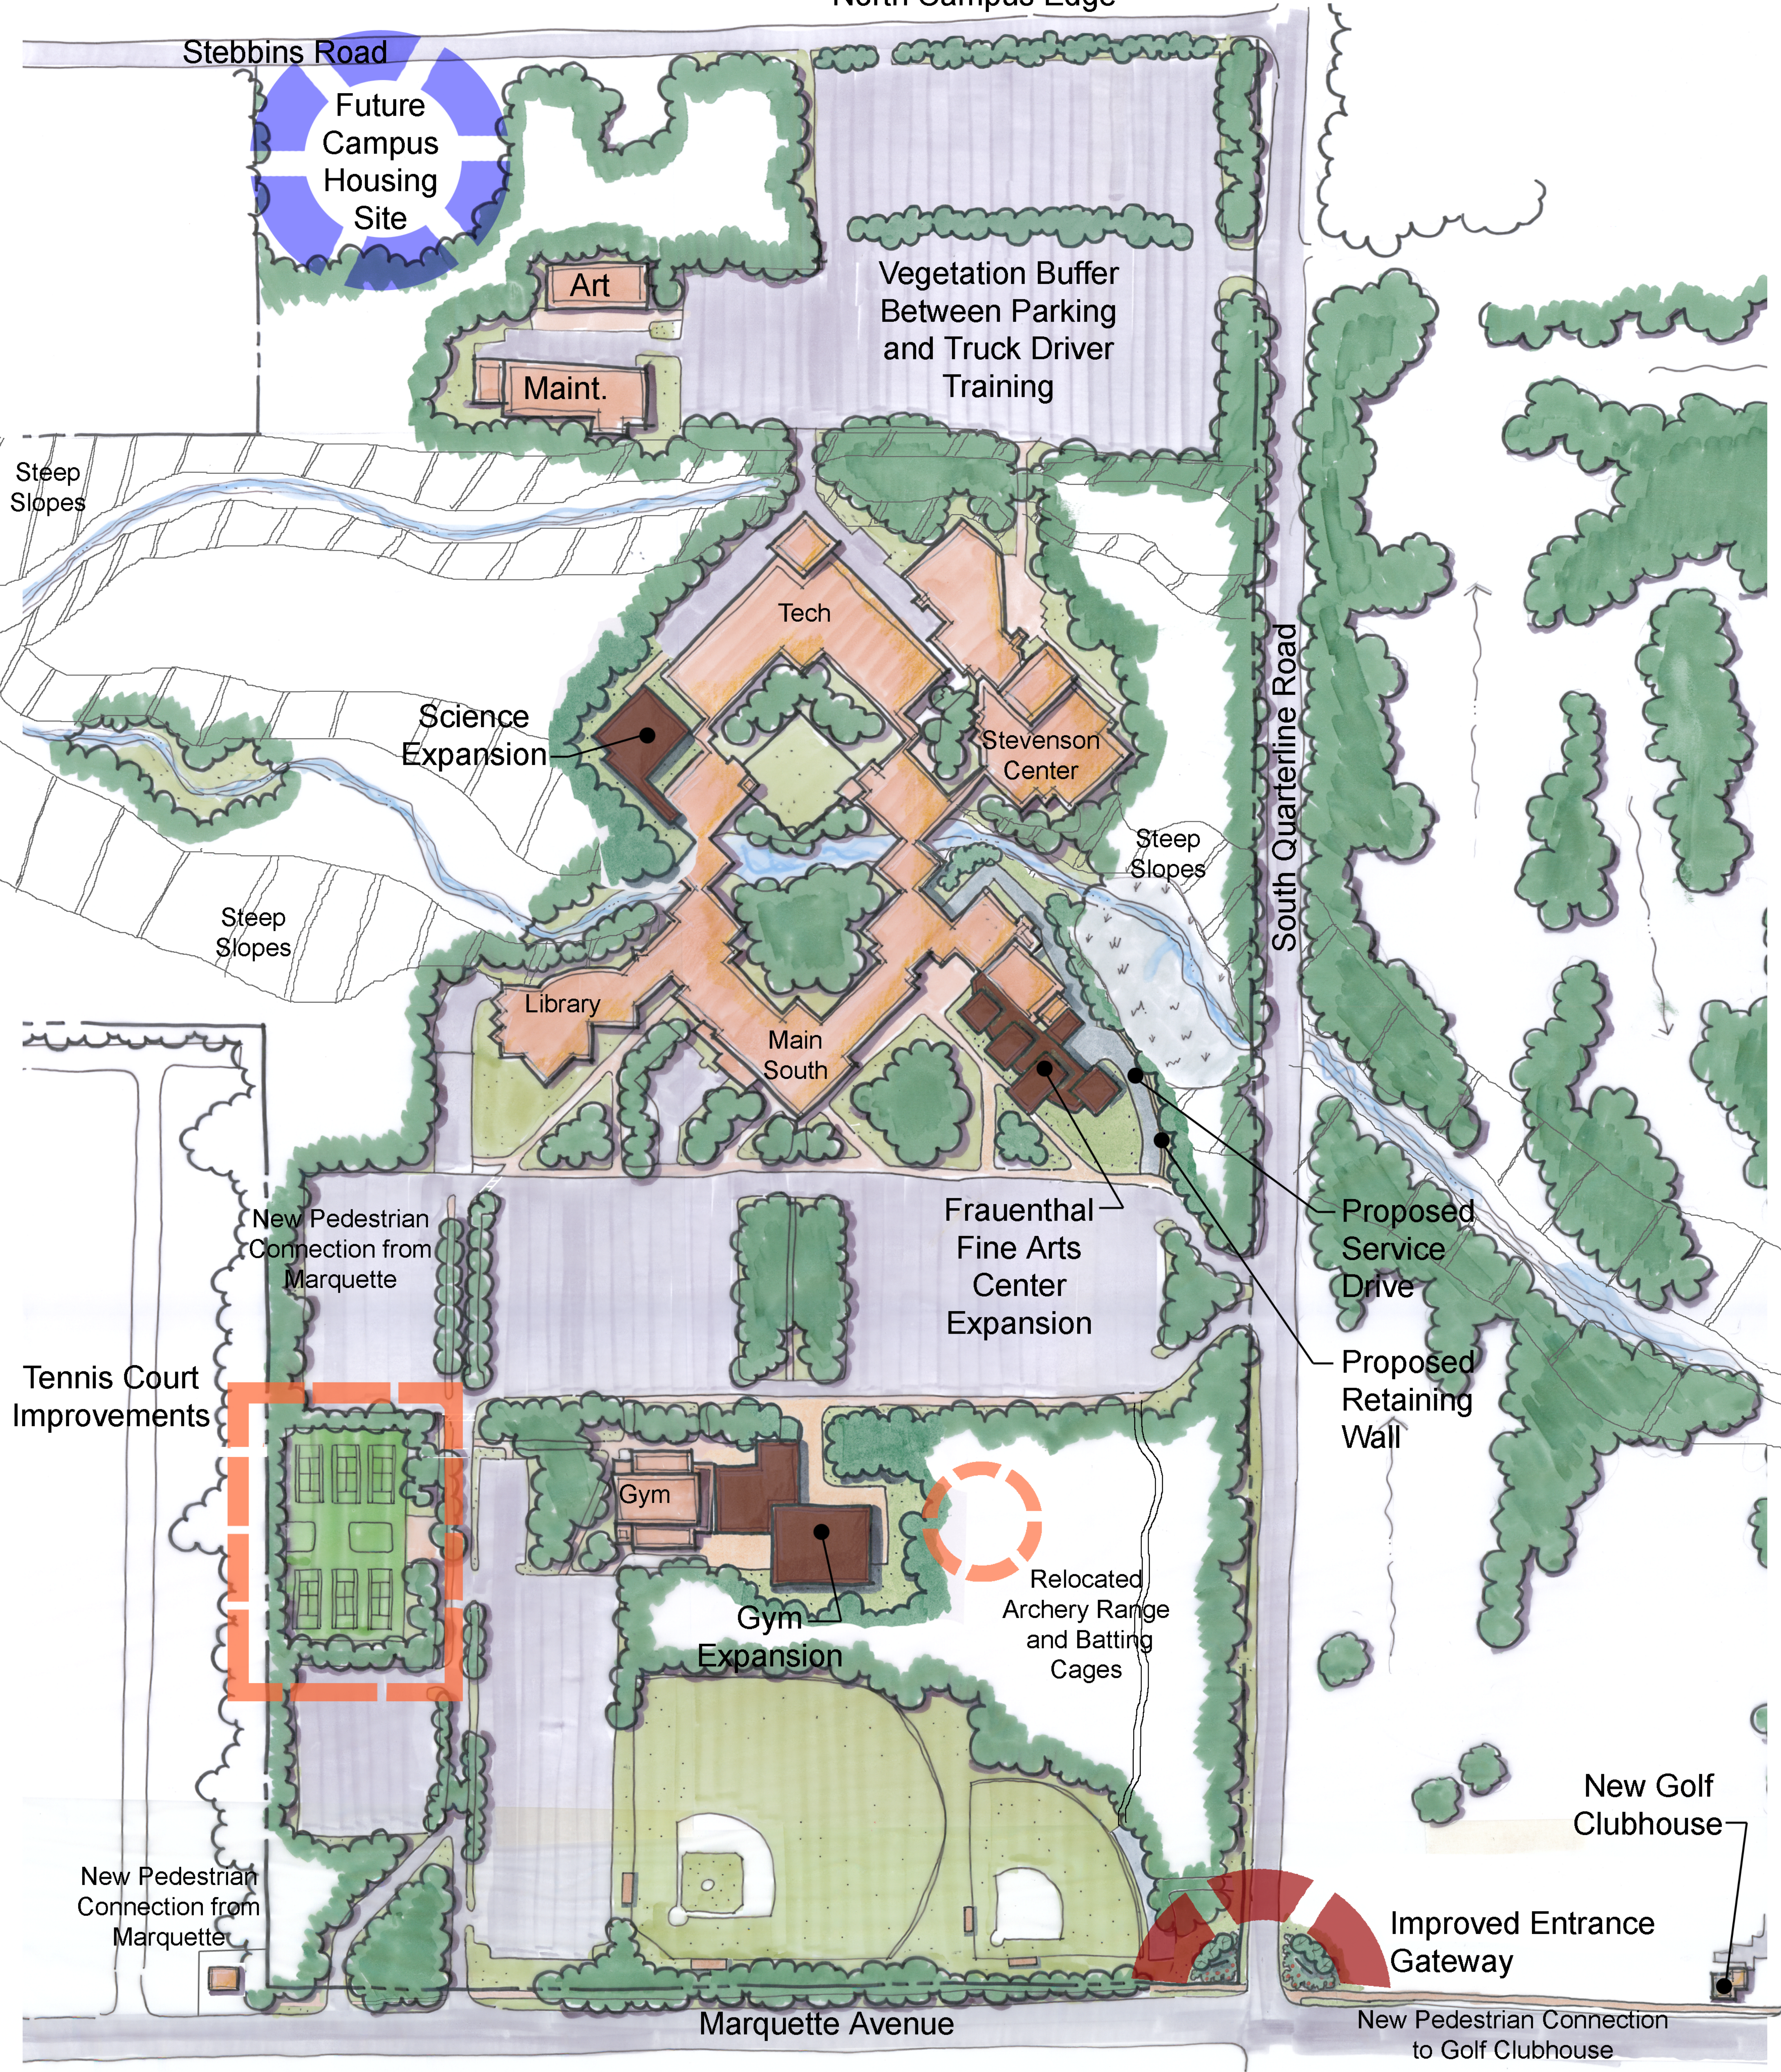
Composite Site Plan

Vegetation Buffer to Define North Campus Edge

1. Enhanced signage at the northeast corner of Marquette and Quarterline, including substantial landscaping backdrop. Improved visibility of campus buildings through existing stands of trees.
2. Definition of a clear campus edge through additional landscaping materials at southwest corner of Quarterline and Stebbins
3. Identification of a future site for potential student housing. In anticipation of potential future housing or other use, MCC should purchase, as they become available, existing residential properties along Stebbins Road to consolidate this property.
4. Expanded archery range
5. Enhanced campus safety and security
6. Renovation of existing tennis courts
