TowerPinkster
Architecture · Engineering · Interiors

NOVEMBER 06, 2024

MUSKEGON COMMUNITY COLLEGE

CAMPUS PLAN REPORT

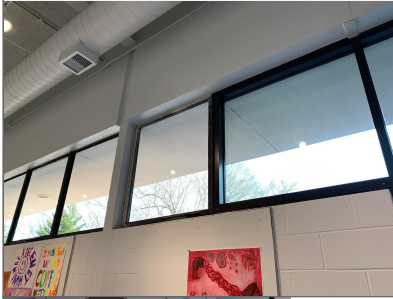
Existing painted clear anodized storefront adjacent to new dark bronze anodized storefront
