TowerPinkster
Architecture · Engineering · Interiors

NOVEMBER 06, 2024

MUSKEGON COMMUNITY COLLEGE

CAMPUS PLAN REPORT

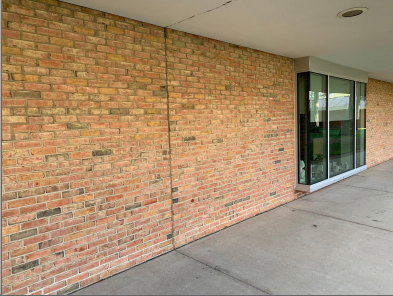
Lack of brick veneer weeps & vents required for adequate cavity wall drainage
